# City of Frostburg

## *LONG TERM CONTROL PLAN UPDATE FOR COMBINED SEWER OVERFLOWS*

*December 2009*

**City of Frostburg**  
**LONG TERM CONTROL PLAN UPDATE**  
**FOR COMBINED SEWER OVERFLOWS**

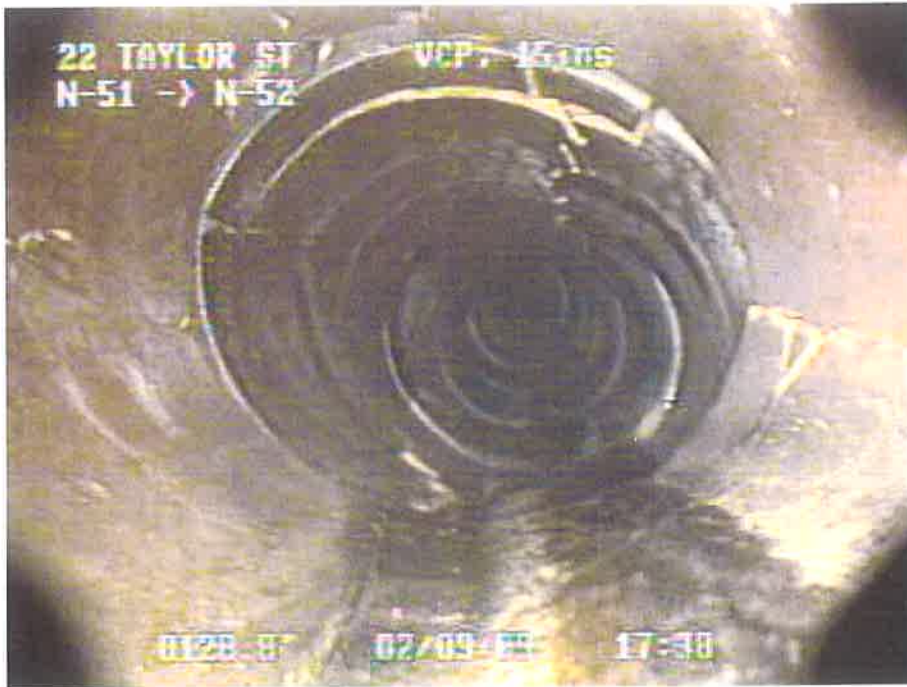
Img-2

The above condition is recorded for approx. 60 liner feet. At approx. 130' east of Taylor St the pipeline has deformed and cracked. See img.-2

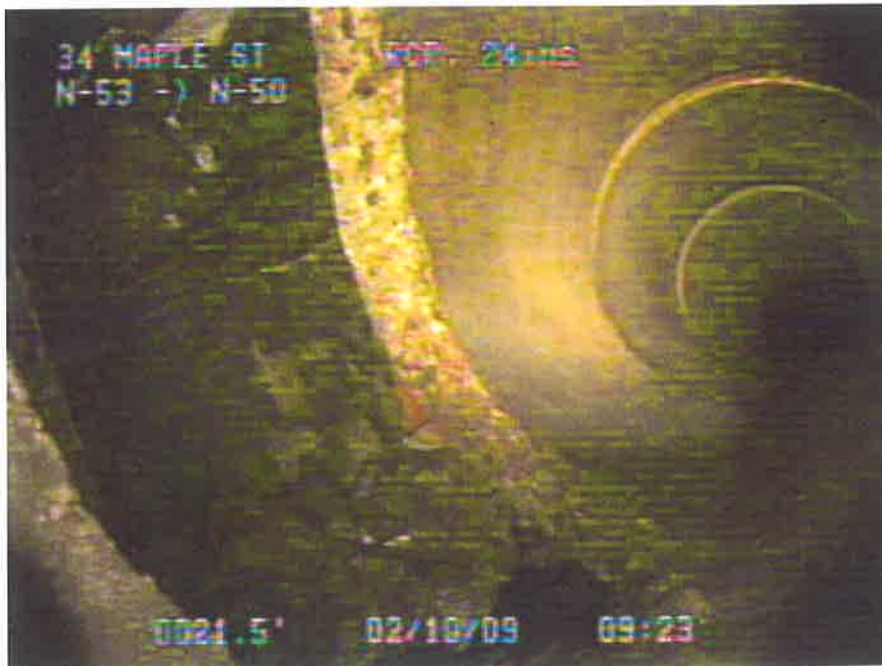
Img.-3

The pipe line changes to 18" at Maple St and continues as 18" to Center St., at approx. 20' east of Maple St a large section of the pipeline is missing with soil visible. See img.-3

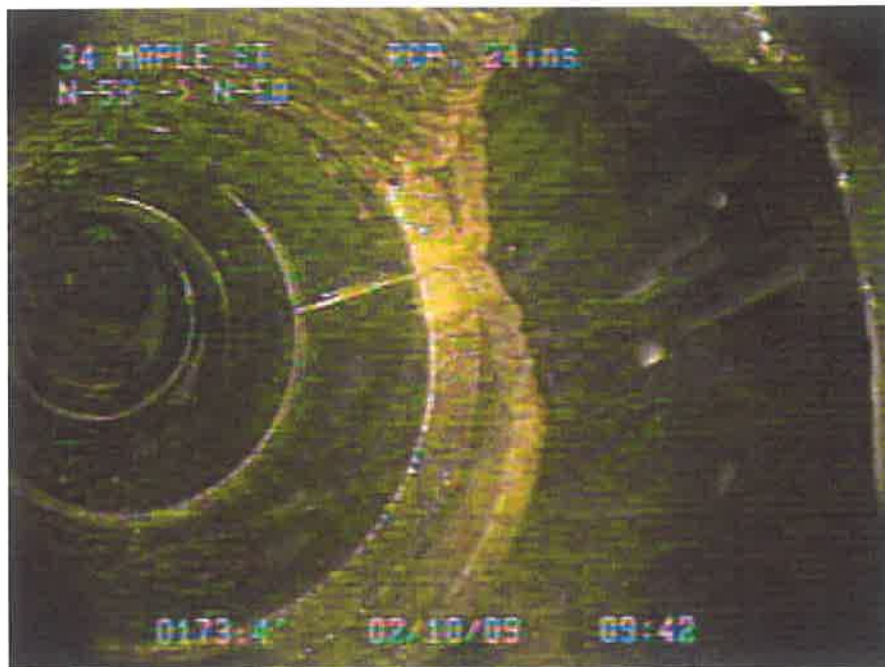
Img.-5

At approx. 175' east of Maple St. at Center St. a large section of the pipe is missing. See img.-5

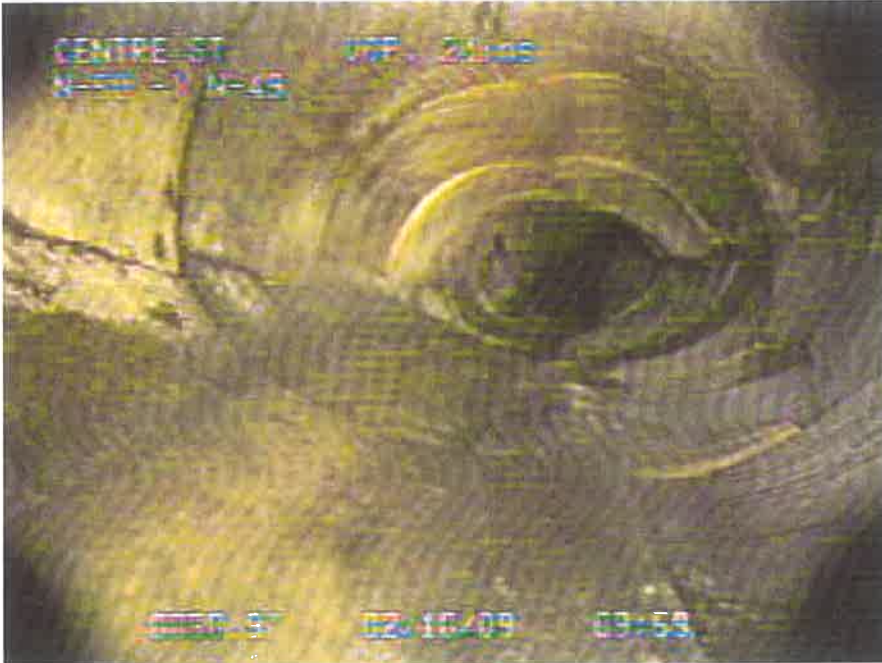
Img.-6

At Center St. the pipeline changes size to 24", at approx. 45' the pipe is fractured and failing. This condition exists for approx. 60 liner feet. See img.-6

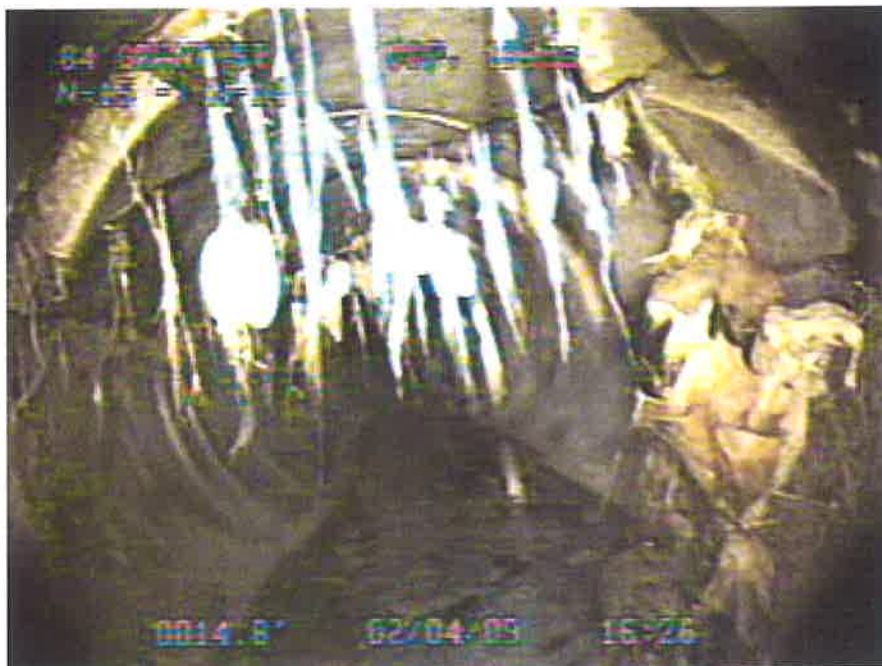
Img.-11

Also televised was a portion of a 18" VCP located in Grant St. this 18" pipeline carries flow from as far away as Main St. CCTV was completed on the first 300' feet located in the Georges Creek study area. At approx. 15' there is root intrusion and fractured pipe. See img.-11

The CCTV work was terminated in this line due to impassable conditions. A root cutter truck and flush truck should be used on this line to complete the analysis. The length of this line to the next upstream manhole is approx. 200'.

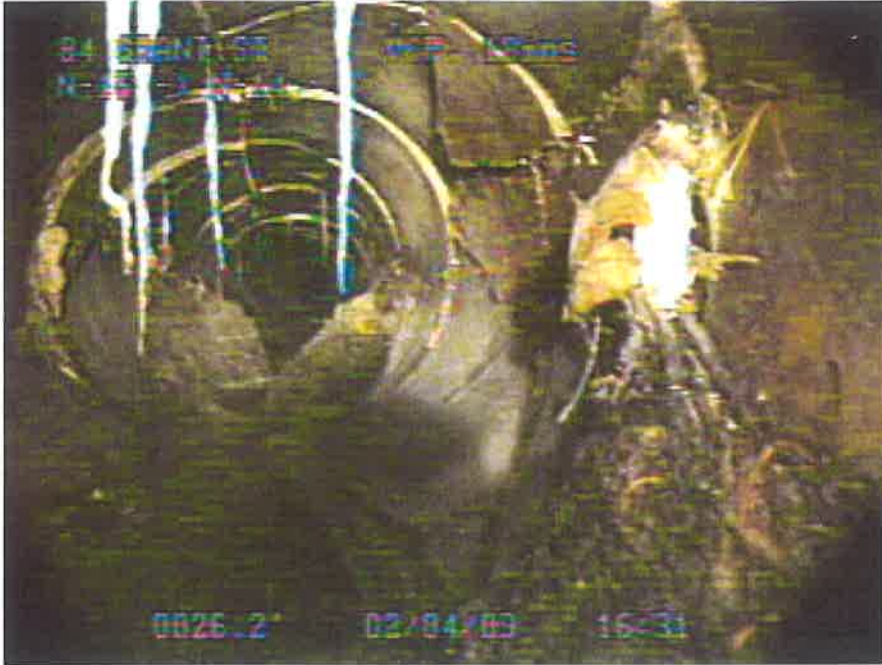
Img.-12

At approx. 23' there is heavy root intrusion and fractured pipe. See img.-12

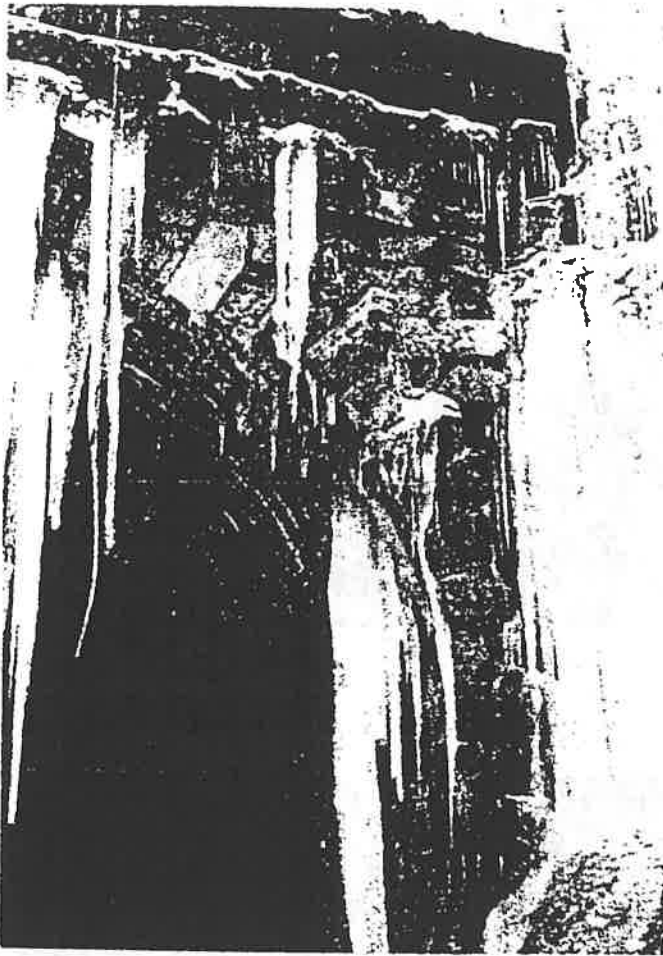
*Photograph No. 3: Deteriorated Masonry at South Portal.*

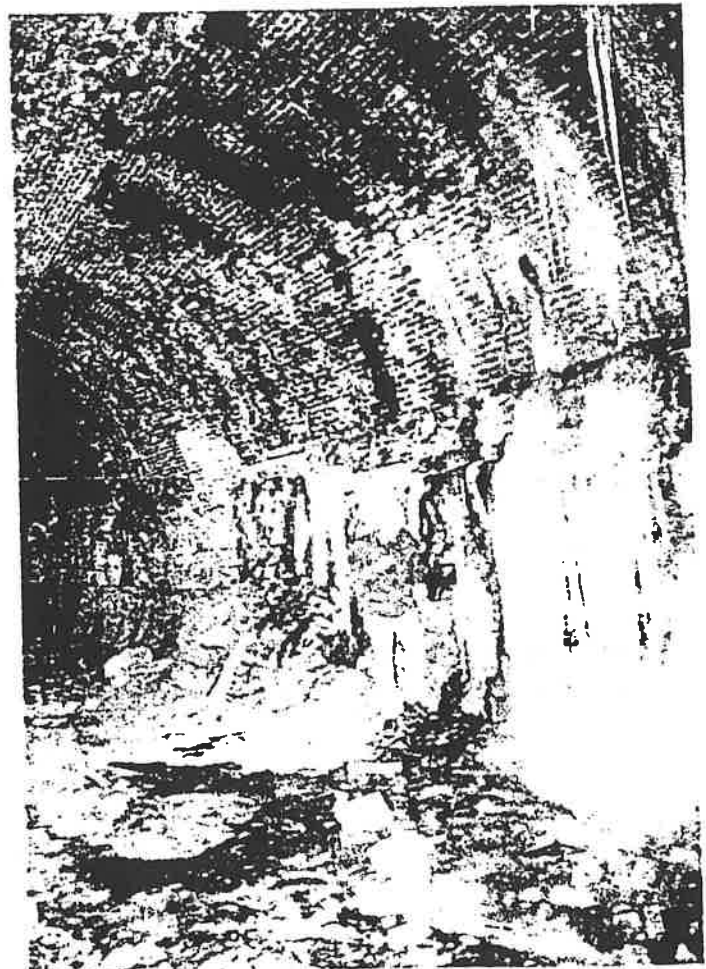
*Photograph No. 12: Spalled Brick Lining at Station 15+00±. Note Also Dislodged Portion of Rock Bench Beneath Spalled Area and Heavy Leakage (Ice) Just North of this Area.*

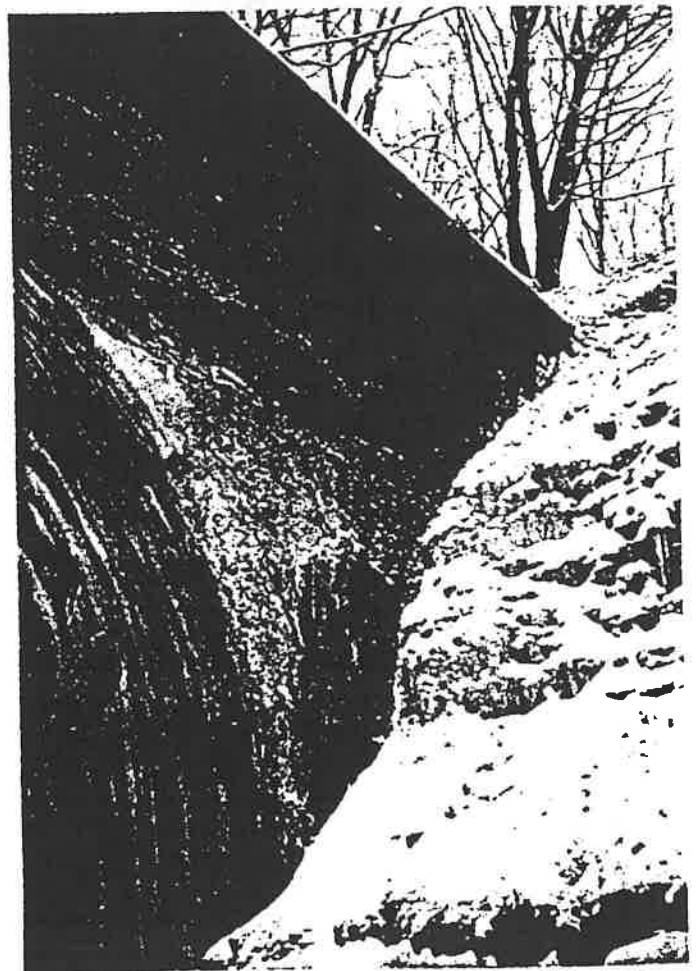
*Photograph 20: Deterioration at West Side of North Portal Wall.*
